**Flood Control Project Maintenance
Levee Inspections**
LMA District Cover Sheet
Spring 2010 Levee Inspection Results

Reclamation District No. 2107

Levee Inspection Report By Mile - Spring 2010

Waterway				Bank	Unit Miles	Inspection Start/End	Inspector
Unit No. 01 San Joaquin River				Left	2.37	03/25/2010 03/25/2010	John Paasch

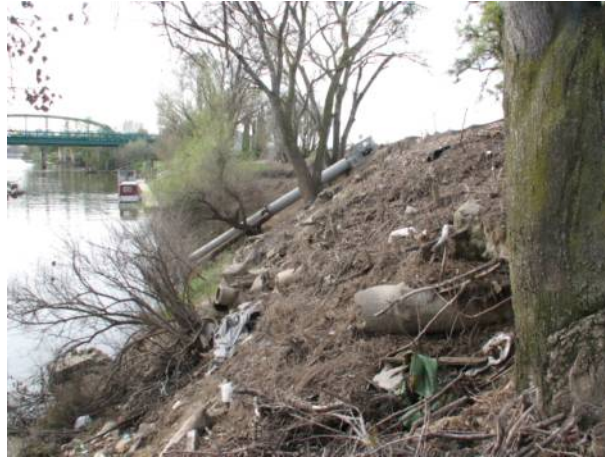
Levee Mile Report Line	2
Start Levee Mile	0.03
End Levee Mile	0.03
Location	Water Side
Category	Earthen Levee
Item	Trim / Thin Trees

Photo of waterside slope. Stumps present from prior tree removal for access and visibility.

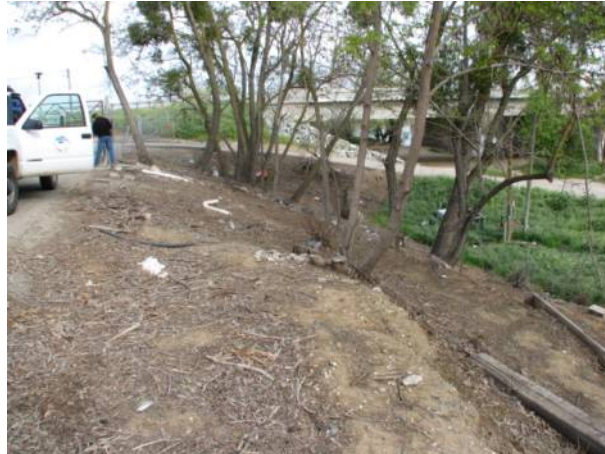
Levee Mile Report Line	4
Start Levee Mile	0.25
End Levee Mile	0.25
Location	Water Side
Category	Earthen Levee
Item	Trim / Thin Trees

Tree stumps present on slope. They were left from prior vegetation removal for access and visibility.

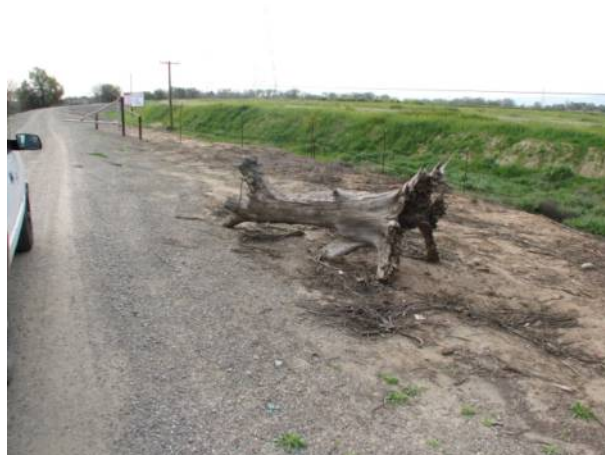
Levee Mile Report Line	6
Start Levee Mile	0.35
End Levee Mile	0.35
Location	Land Side
Category	Earthen Levee
Item	Encroachments

Tree trunk on landside levee slope.

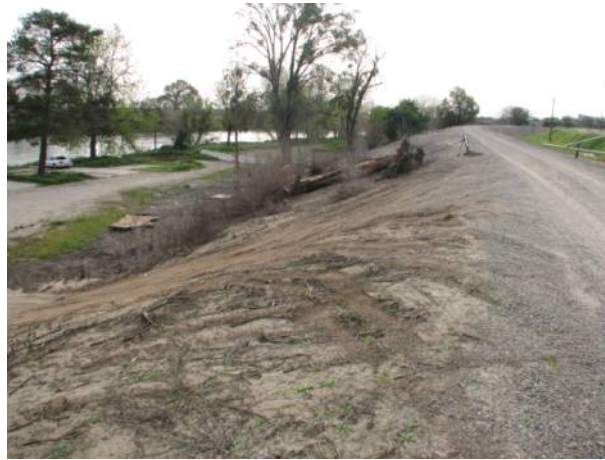
Levee Mile Report Line	7
Start Levee Mile	0.37
End Levee Mile	0.37
Location	Water Side
Category	Earthen Levee
Item	Trim / Thin Trees

Tree stumps and trunks on levee slope. Vehicle traffic on levee slope is an ongoing problem at this location due to the abandoned trailer park, access should be restricted.

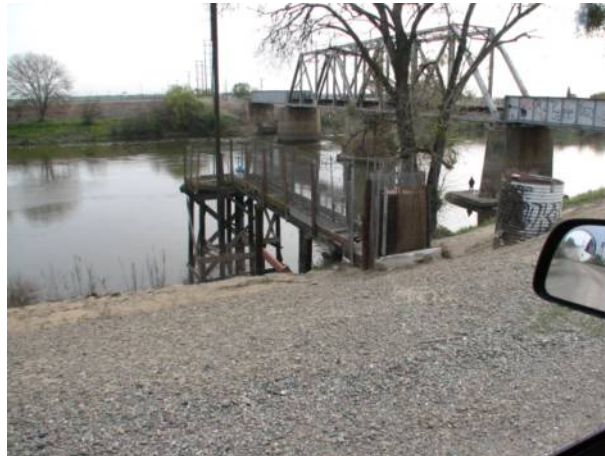
Levee Mile Report Line	9
Start Levee Mile	0.68
End Levee Mile	0.68
Location	Crown
Category	Earthen Levee
Item	Encroachments

Irrigation intake pipe runs through the base of the levee. Stand pipes on waterside and landside. A Butterfly valve is located near waterside slope.

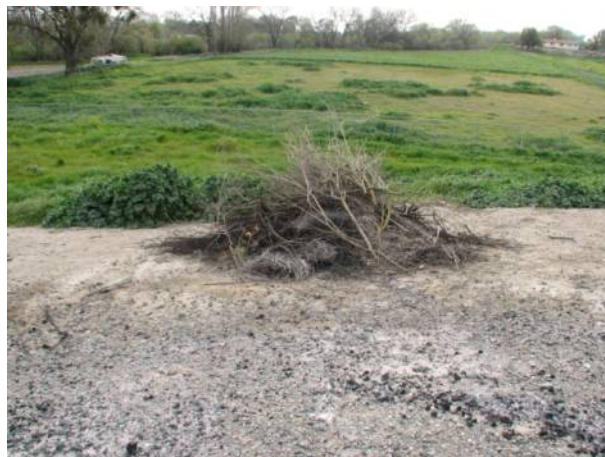
Levee Mile Report Line	11
Start Levee Mile	1.23
End Levee Mile	1.23
Location	Water Side
Category	Earthen Levee
Item	Encroachments

Tree prunings have been piled for burning on levee slope.

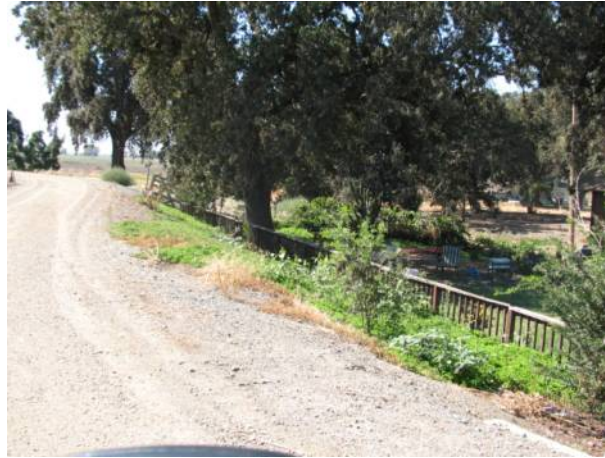
Levee Mile Report Line	13
Start Levee Mile	1.24
End Levee Mile	1.24
Location	Land Side
Category	Earthen Levee
Item	Encroachments

Fall 2009 photo of landscape planting on landside levee slope and a 3-ft yard fence at the levee toe.

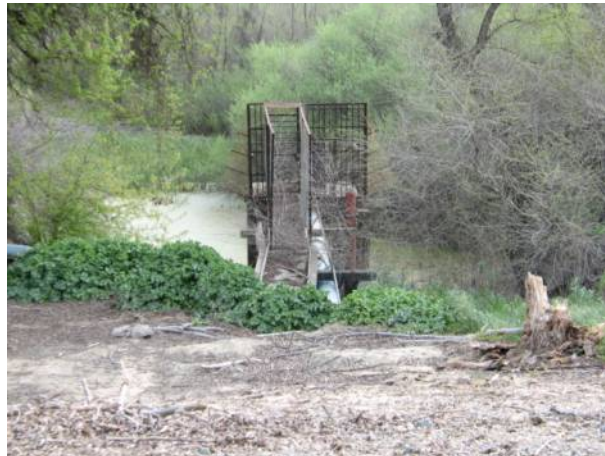
Levee Mile Report Line	14
Start Levee Mile	1.49
End Levee Mile	1.49
Location	Crown
Category	Earthen Levee
Item	Encroachments

Irrigation intake pipe through levee free board.

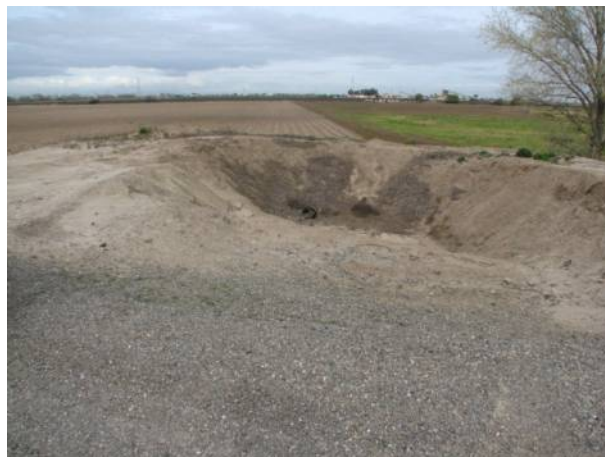
Levee Mile Report Line	16
Start Levee Mile	1.85
End Levee Mile	1.85
Location	Crown
Category	Earthen Levee
Item	Seepage / Sandboils

Coffer dam built due to seepage during a previous high water event.

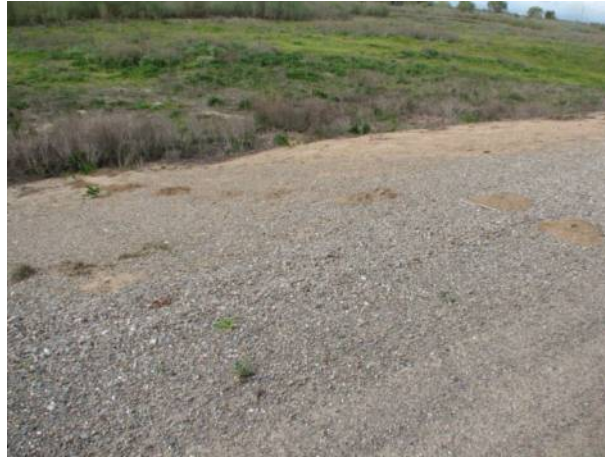
Levee Mile Report Line	1
Start Levee Mile	0.14
End Levee Mile	0.14
Location	Crown
Category	Earthen Levee
Item	Animal Control

Animal burrowing activity on levee slope.

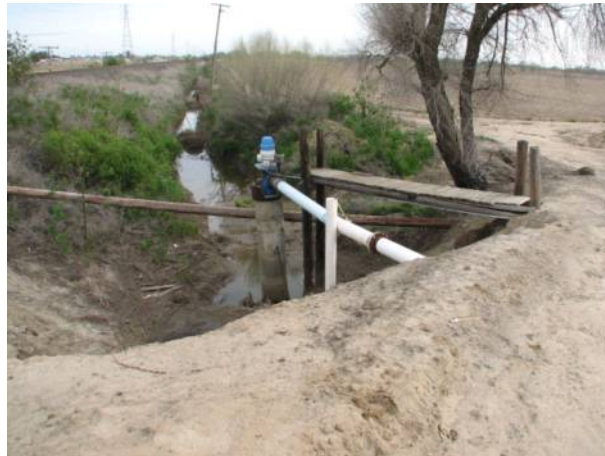
Levee Mile Report Line	2
Start Levee Mile	0.55
End Levee Mile	0.55
Location	Crown
Category	Earthen Levee
Item	Encroachments

Drainage discharge pump. Steel pipe penetrates levee freeboard. No flapgate on waterside. No closure device.

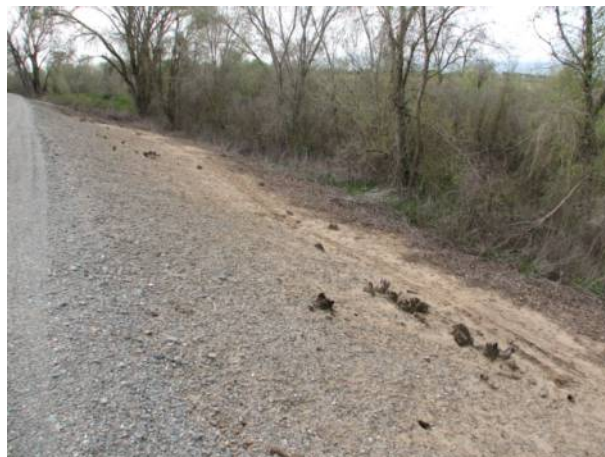
Levee Mile Report Line	3
Start Levee Mile	0.84
End Levee Mile	0.84
Location	Water Side
Category	Earthen Levee
Item	Trim / Thin Trees

Tree stumps on levee slope.

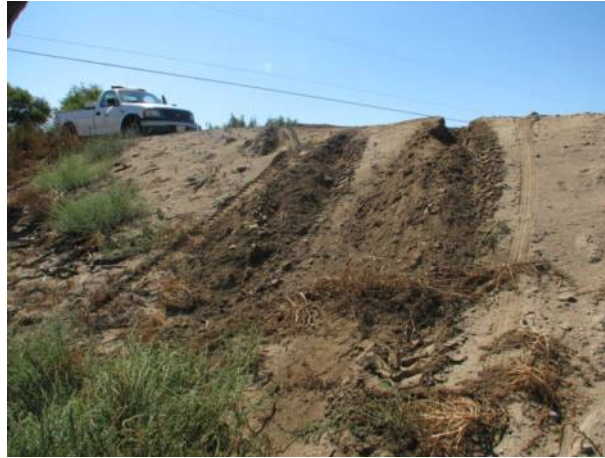
Levee Mile Report Line	4
Start Levee Mile	1.29
End Levee Mile	1.29
Location	Land Side
Category	Earthen Levee
Item	Slope Stability

Fall 2009 photo of wheel ruts on landside levee slope.

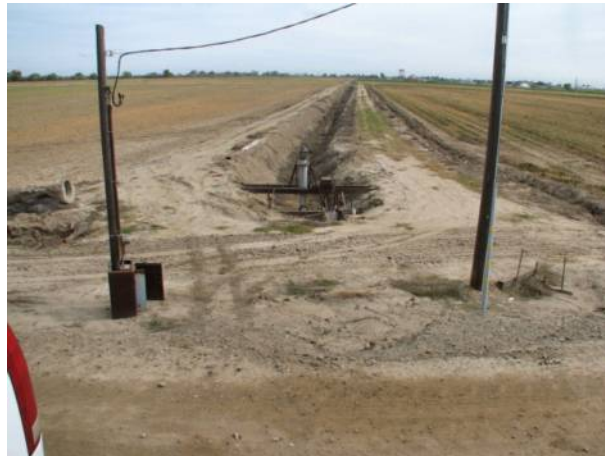
Levee Mile Report Line	6
Start Levee Mile	1.53
End Levee Mile	1.53
Location	Crown
Category	Earthen Levee
Item	Encroachments

6	1.53	1.53	Earthen Levee	Encroachments	CR	W	Pipe Inspector Comments: Drainage discharge into Paradise Cut. Gravity flow and pressure flow from sump pump if necessary. Power to pump disconnected. Pump in disrepair. No flap gates or closure devices.	37.774170 ° -121.329954 °	37.774170 ° -121.329954 °	6 Y

Drainage discharge pump inoperable. Parallel gravity drainage to Paradise Cut.
